**TARRYTOWN WATERWORKS DAM
WESTCHESTER COUNTY, NEW YORK
INVENTORY NO. 54**

**PHASE I INSPECTION REPORT
NATIONAL DAM SAFETY PROGRAM**

NEW YORK DISTRICT CORPS OF ENGINEERS

SEPTEMBER 1978

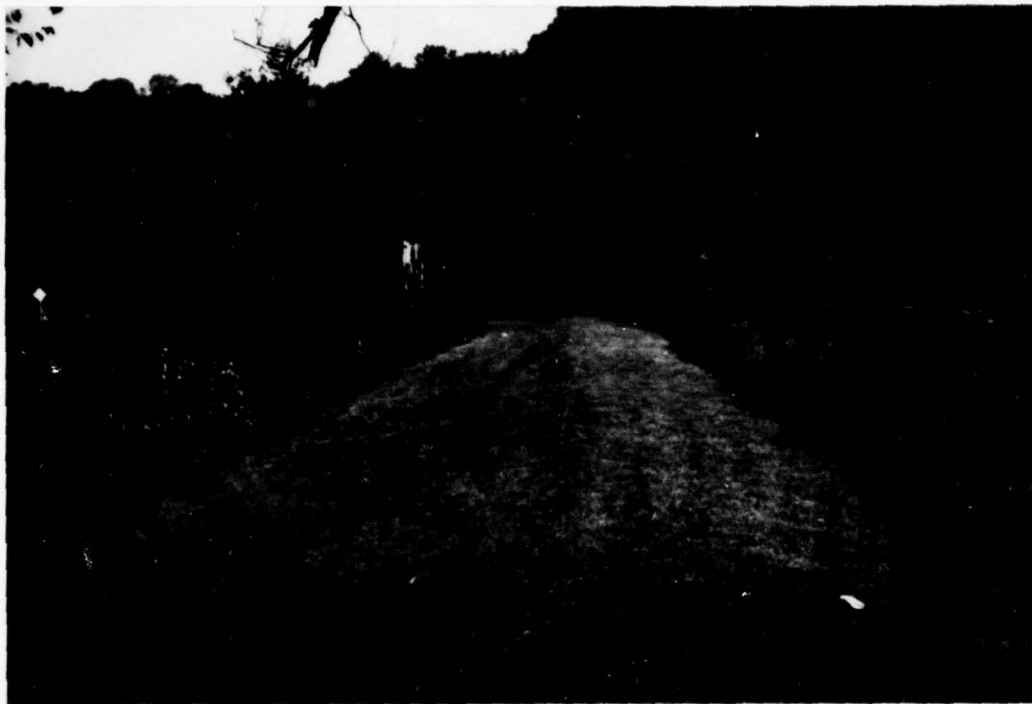
The earth embankment appears to be in generally good condition. The horizontal and vertical alignments of the crest are generally good except for some minor rutting and a few depressions about 3 feet in diameter and 4 inches deep. A shaft located on the crest about 10 feet south of the gatehouse was an access to an alum injection system which is no longer in use. The shaft is covered with a steel plate.

2) CREST OF DAM LOOKING NORTH , NOTE RUT ALONG CENTER OF CREST

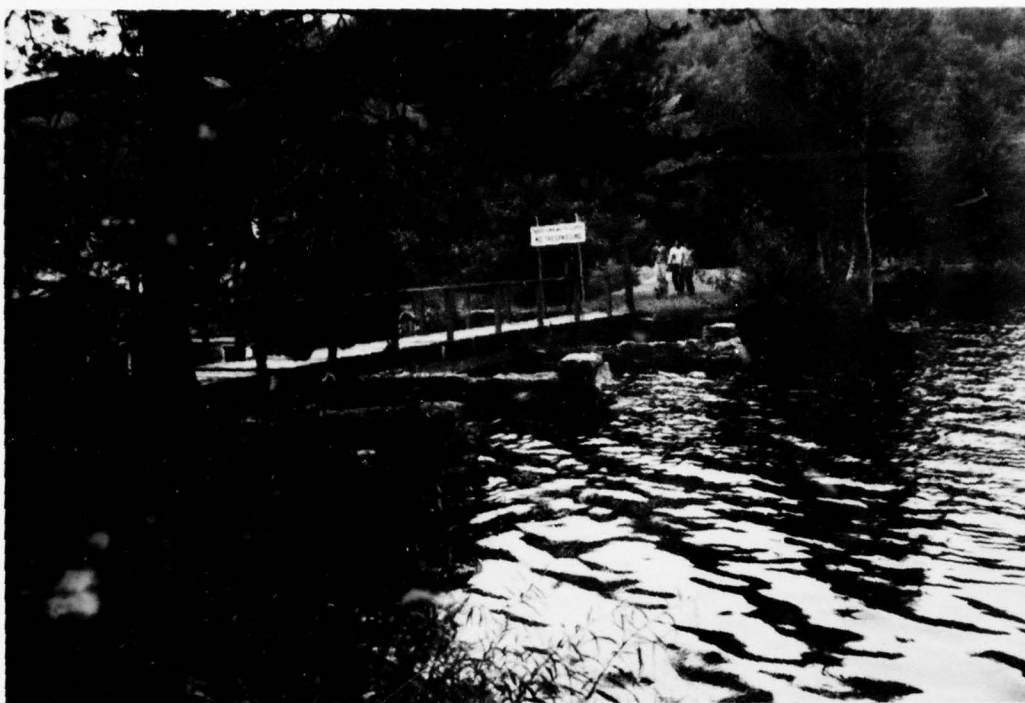
The stone masonry training walls are in generally good condition. The upstream walls, however, do have loose and missing pointing. The walls which support the pedestrian bridge have several loose and missing stones as well as missing mortar. The downstream walls are in good condition, with only minimal loose pointing. The wood decking of the bridge is in poor condition.

7) APPROACH CHANNELS TO SPILLWAY

- f) Repair the loose masonry along the training walls and spillway chute, adding new pointing where necessary.
- g) Remove the loose concrete blocks from spillway channel.

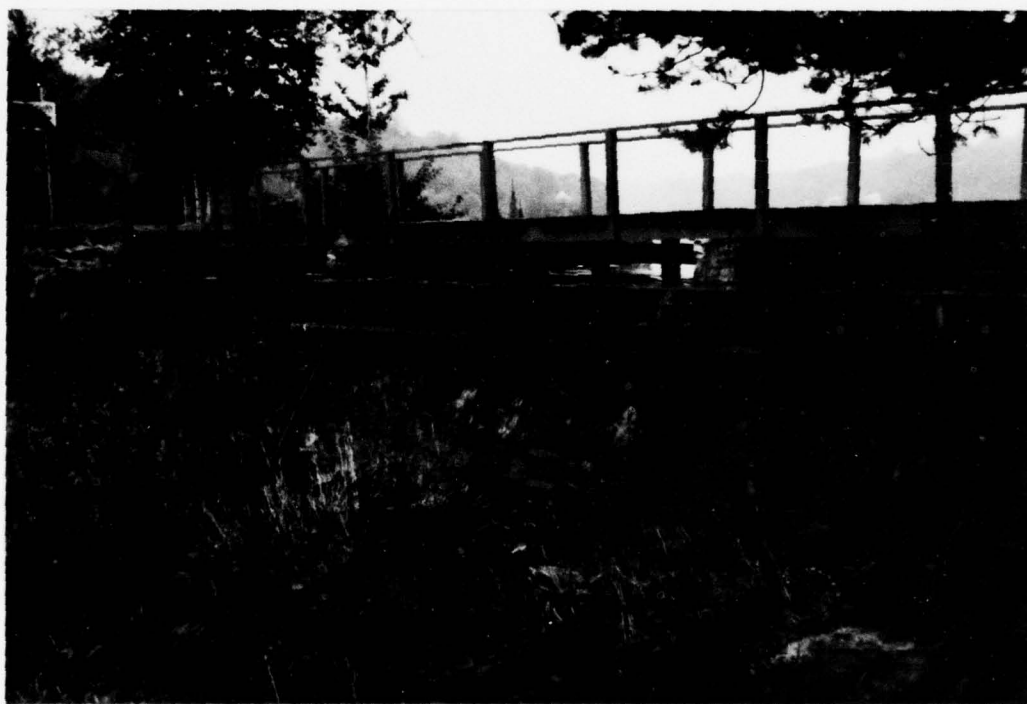
The spillway appears to be in generally fair condition. The concrete capping is in good condition and there is relatively new pointing on the stone masonry chute. There are, however, several loose and missing stones at the bottom of the chute. Several leaks were observed at the contact

between the concrete and stone masonry. A small leak averages about 1 to 3 gpm. A slightly larger leak, located about 7 feet from the south end of the spillway averages about 5 to 10 gpm. In addition, there is vegetation at the contact and on the sill. The upstream approach to the spillway is clear with the exception of some aquatic weeds. These weeds are reportedly periodically destroyed by the use of copper sulphate, a herbicide and an algaecide.

8) SPILLWAY CHUTE, NOTE DISPLACED MASONRY AT CHUTE TOE

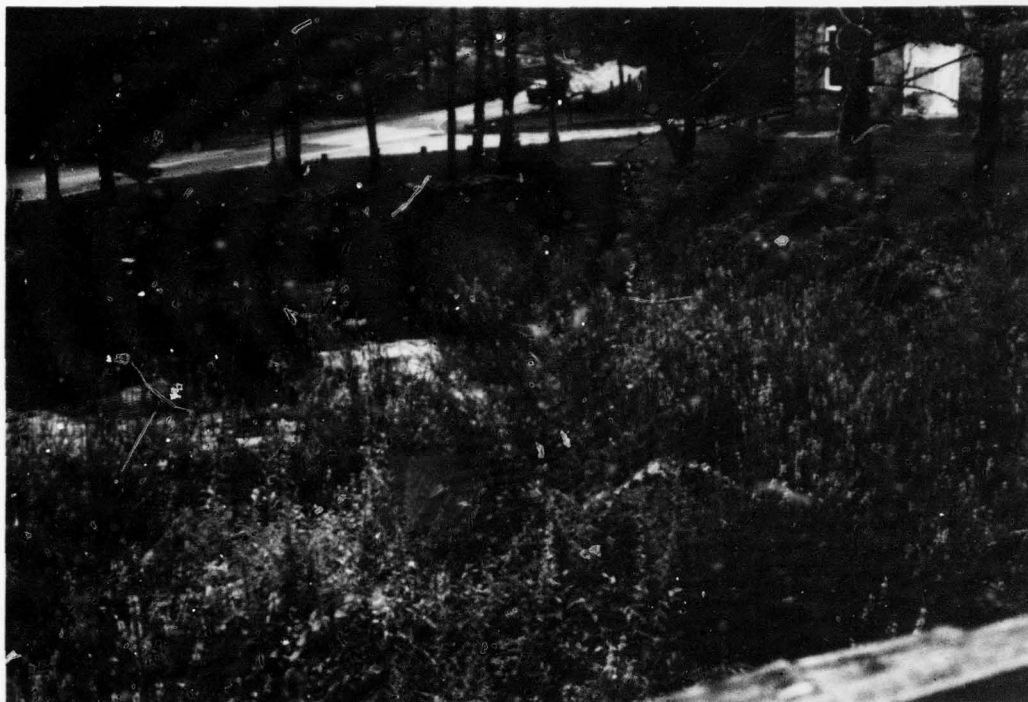
The channel immediately downstream from the spillway is heavily overgrown with vegetation. There are blocks of concrete at the bottom of the spillway chute. However, the minor flows which were observed were not impeded by this condition. The channel, further downstream, is a natural creek with only minimal vegetation and no overhanging trees.

9) SPILLWAY CHANNEL LOOKING DOWNSTREAM, NOTE ENTRANCE OF CONDUIT AND HEAVY VEGETATION

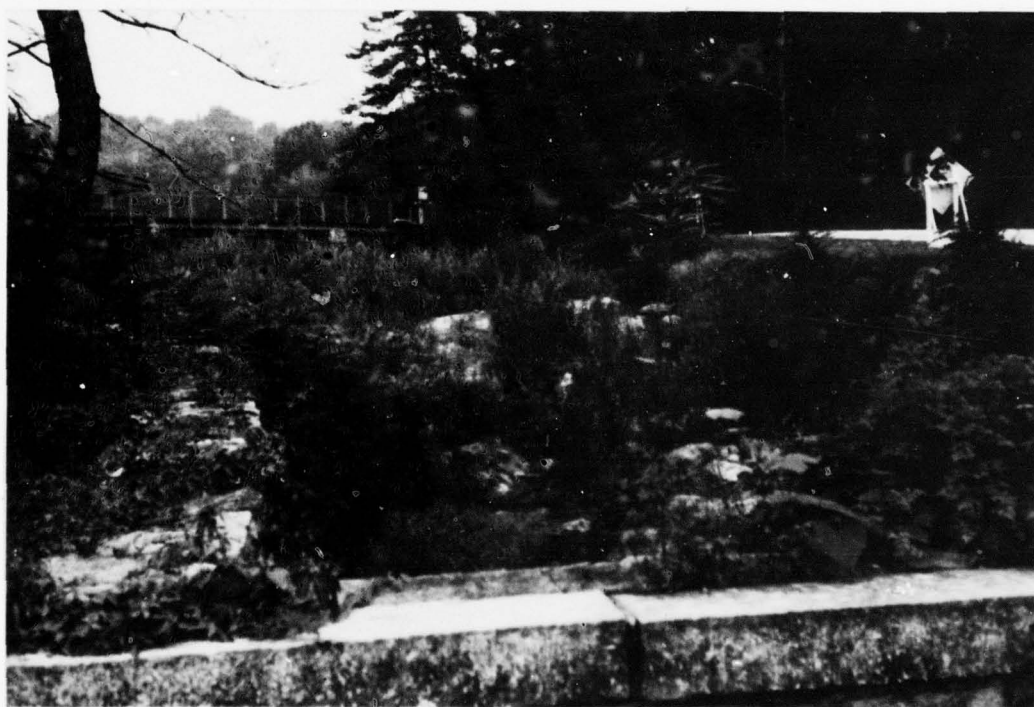
10) SPILLWAY CHANNEL LOOKING UPSTREAM

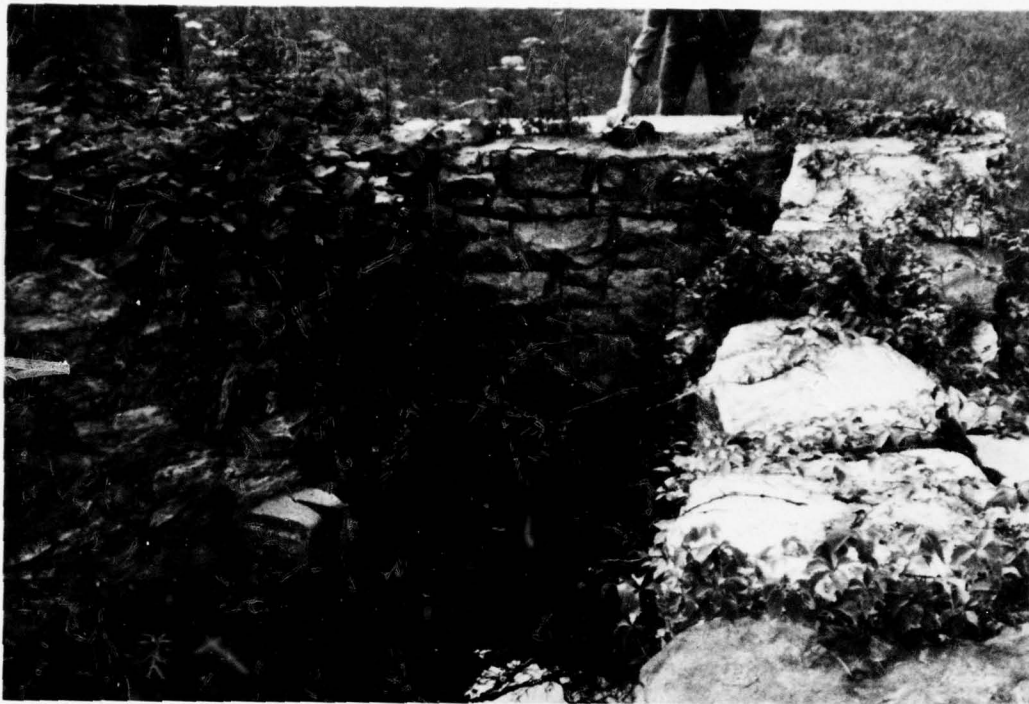
11) ENTRANCE OF CONDUIT, NOTE MEASURING WIER

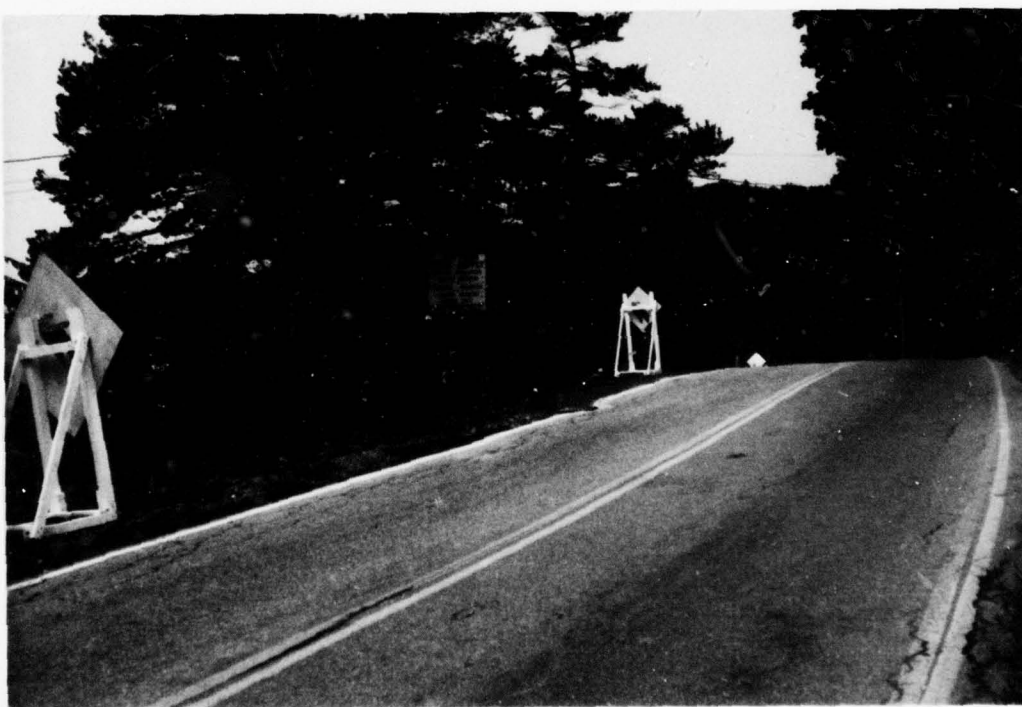
12) ROADWAY (NEPERAN ROAD) NORTH AND UPSTREAM OF SPILLWAY,
NOTE DEPRESSED AREA BETWEEN ROAD AND TARRYTOWN WATER
SUPPLY SIGN
